FI Con 2 instruction manual for GROM				
Product number 05-04-0016 Applicable model GROM(JC61-1000001 ~) Characteristic This compact controller already has preset data for sever	Thank you for your purchase of our product. Please so you will comply with the following matters at the time of use. Please check your always kit contents before mounting.If there is a point of notice, please consult the dealer of purchase. If the description, such as photos or Illustration different with this part. al engine parts. Injection controller which can be changed the settings easily			
by switching the rotary switch of the main body.Built-in m turning the rotary switch.	aps of the fuel injection, can be increased or decreased slightly by simply			
 bility for compensation. If trouble occurs in the other components with the use not assume any in any such matters. When it is machining like the products and mounting, de Please refrain from inquiries about the product and the This product is a dedicated products of the type of ve Please apply at the repair part number if attached to Only for GROM (JC61) ,which is Japanese domestic official

■ How to Use and Set the FI CON2

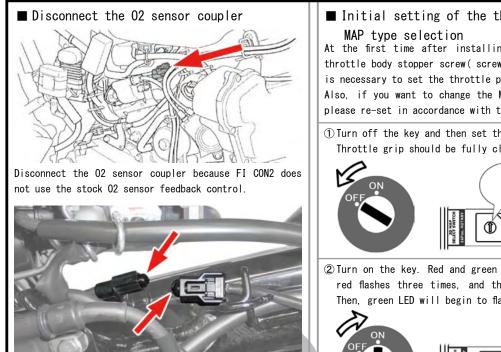
Disconnect the O2 sensor 1P coupler at the back of the ignition coil at right side of the vehicle. Please insert the ϕ 6 cap(smaller) included in the kit to the main harness side, and the ϕ 7.5 cap (larger) to the 02 sensor side coupler.

Please be sure to disconnect the 1P coupler of the O2 sensor. Otherwise, it will be cause that the FI Con 2 does not work correctly at original setting.
